SECOND ENDORSEMENT on NATC PaxRiv Md AAR ser 18-56 concerning A4D-1, BuNo 137816, accident occurring 13 Aug 1956, pilot LONG

Subj: Naval Air Test Center, Patuxent River, Maryland Aircraft Accident Report 18-56; forwarding of

## AIRCRAFT ACCIDENT REPORT

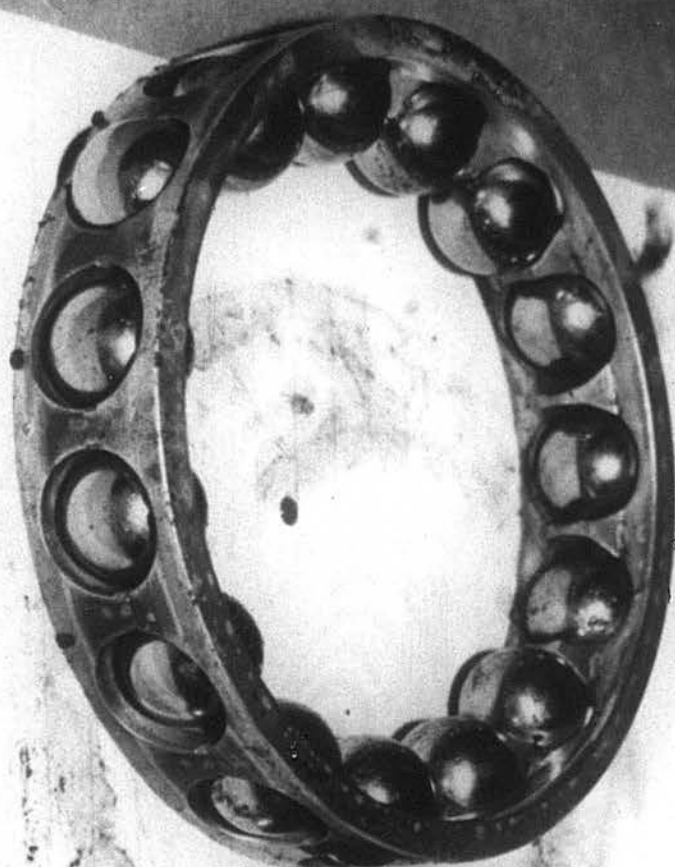
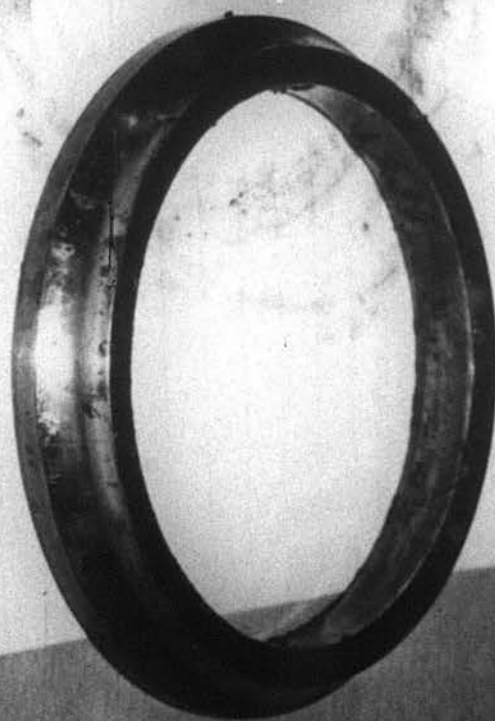
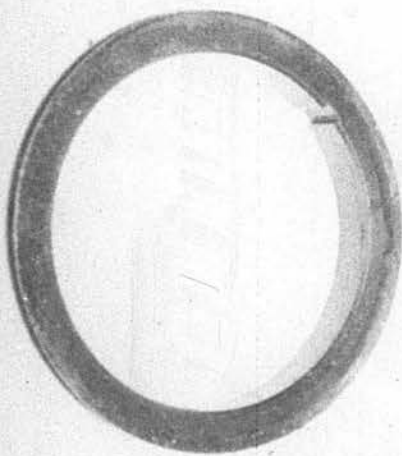
FRONT MAIN  
BEARING

(b) Foreign matter, which was confirmed to be a mud sediment by laboratory analysis, was found to be present on inner cavity surfaces.

(c) The front main bearing suffered no impact damage and was in good condition.

(d) The front main bearing support and minor components with the exception of item (a) suffered no damage.

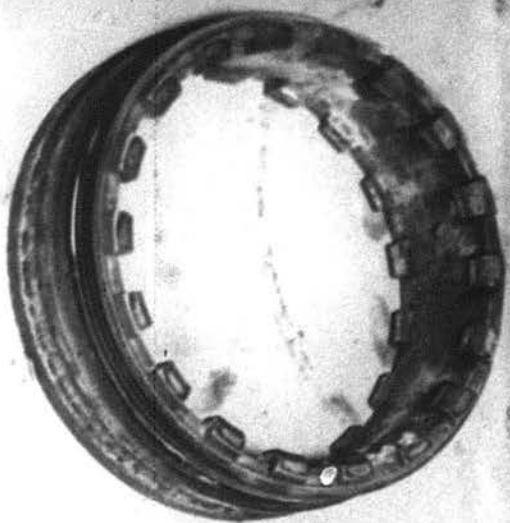
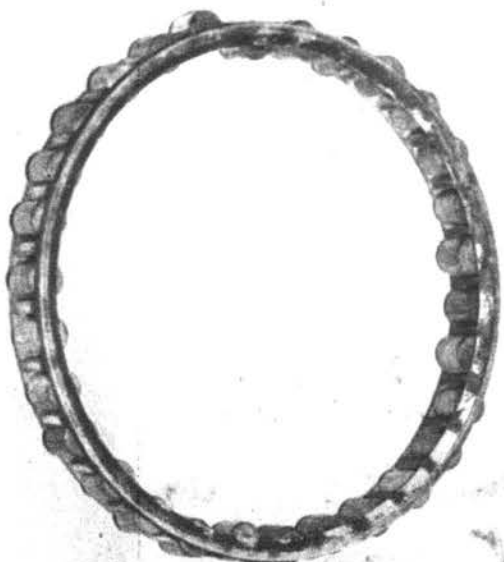
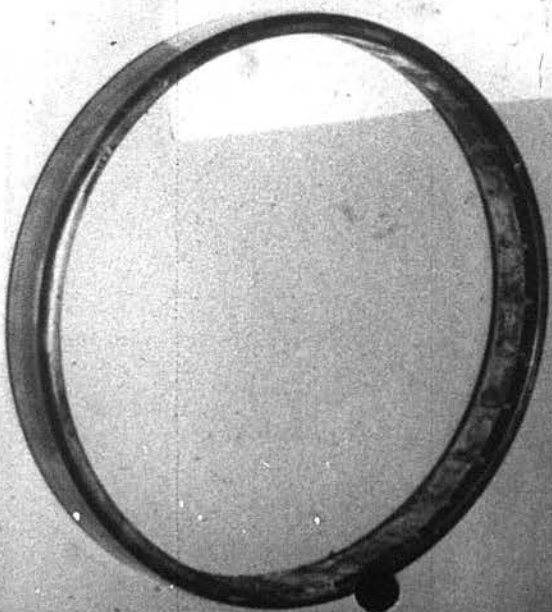
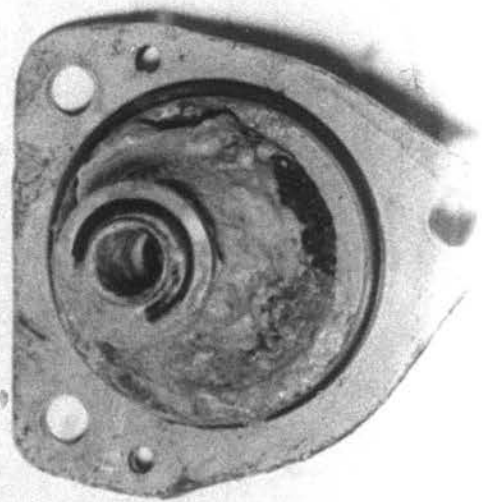
CENTER MAIN  
BEARING  
~~BEARING~~ DISSEMPLED

(a) The center main bearing support and its minor components did not suffer any apparent damage as a result of the crash.

(b) The center main bearing was lightly contaminated with mud and was in initial stages of corrosion but did not display any evidence of distress. It was apparent that the bearing had been lubricated properly prior to the incident.

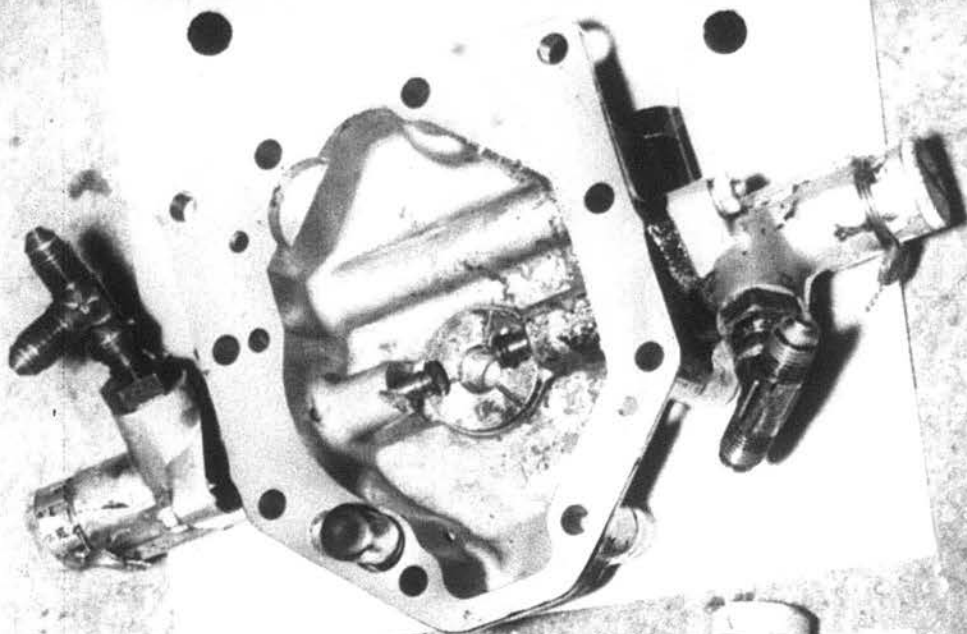
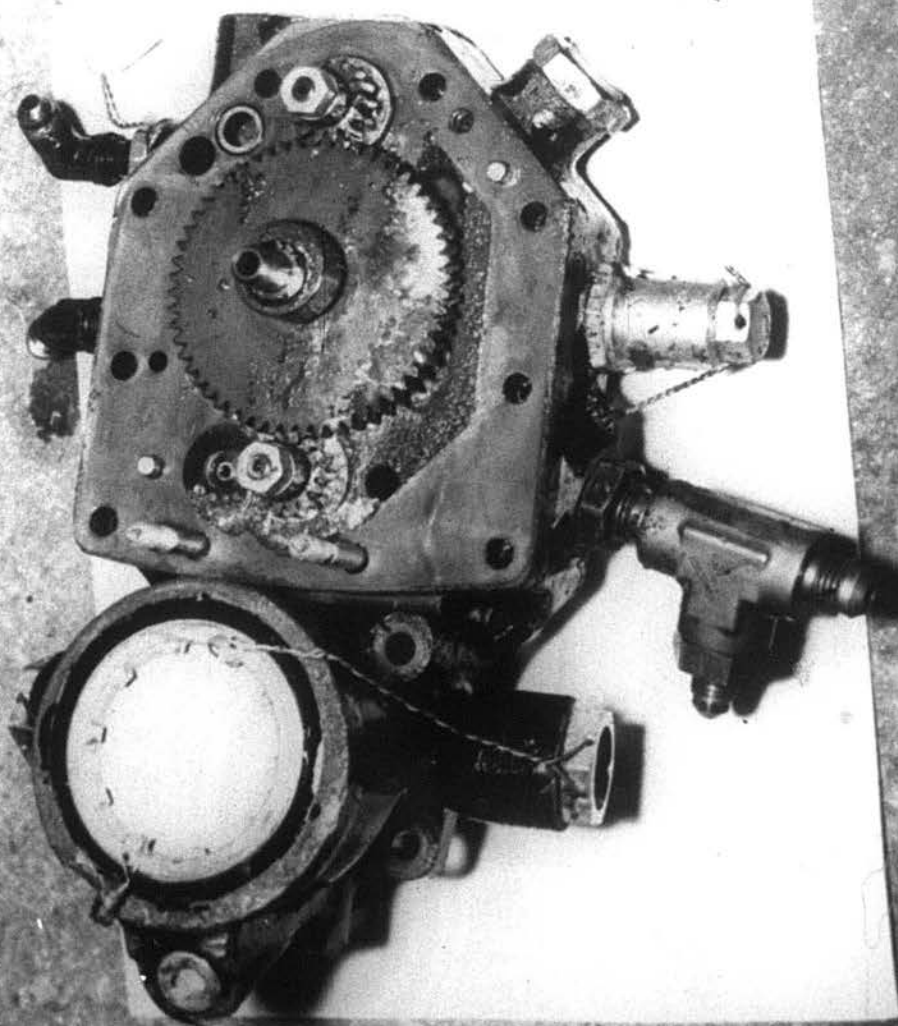
ENGINE DRIVEN FOEC

(d) Fuel Control - The control suffered minor impact damage to:

(1) the compressor pressure limiter assembly which was cracked at the mounting flanges,

The control was found to contain some fuel and water on initial investigation, but no estimate of fuel quantity present in the control at time of impact could be made because of the cracked assembly. The control was returned to Curtis-Wright and the damaged components noted above were replaced with like servicable items. The results of the testing indicated no malfunctioning of the control under any of the variables (maximum flow, minimum flow, acceleration-deceleration, adjustment and correct functioning of altitude and temperature compensation devices) that might have been conducive to engine flame-out. 11
